Engineering Structures

Installation of a base isolation system made of friction pendulum sliding isolators in a historic masonry orthodox church

Vlad Lupășteanu*, Lucian Soveja, Radu Lupășteanu, Costel Chingălată

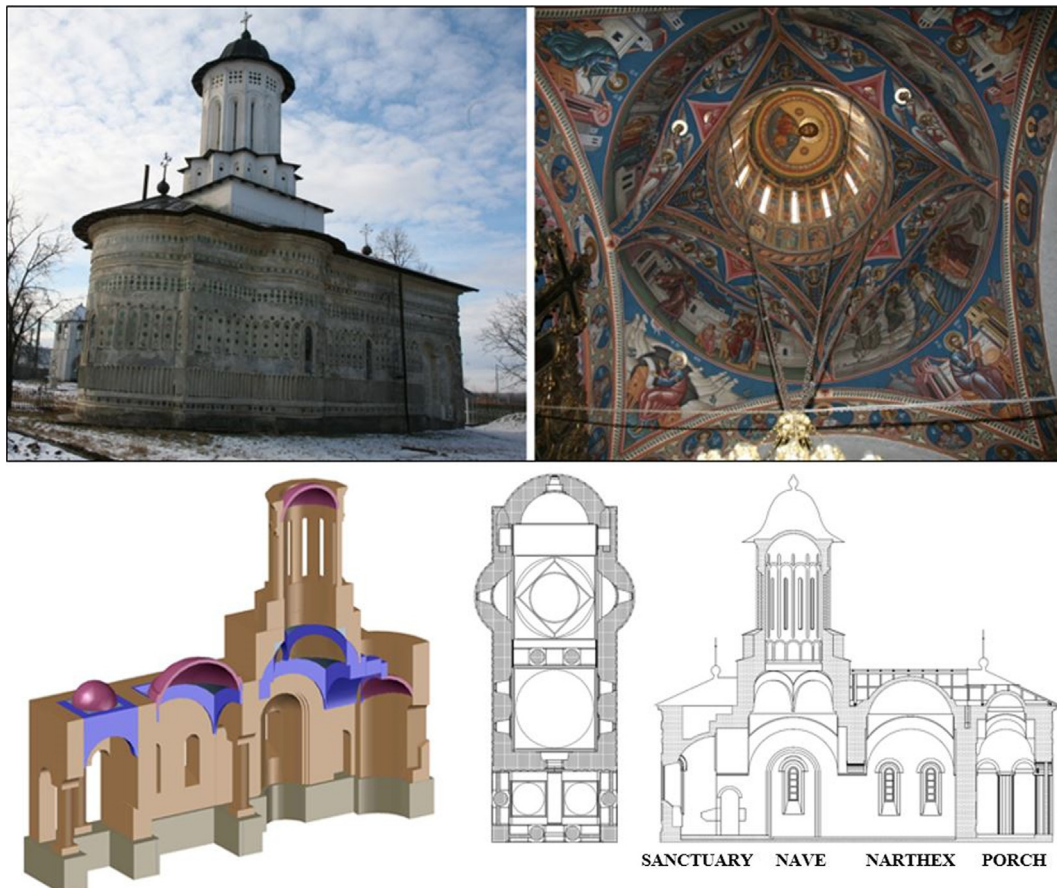
Fig. 3. St. Nicolae Aroneanu church: northern façade, the interior tower, 3D model – isometric view, plan view of walls and vaults, longitudinal section.

From functional and architectural points of view, the Orthodox Church buildings are characterized by certain particularities, as presented in Fig. 3, with respect to their shape, structure, types of elements etc. The vertical structural system of St. Nicolae Aroneanu church, erected in 1594, consists of brick masonry walls, being 1.20 m thick. At the ground level, the walls are resting on continuous footings made of cut stones, bound with lime mortar, having thicknesses similar to those of the above brick masonry walls. The foundations of the church are made of raw coarse stone blocks (limestone and sandstone), bound with lime mortar, having a depth of approximately 1.60 m, being 1.9–2.15 m below the present-day ground level. All horizontal structural elements

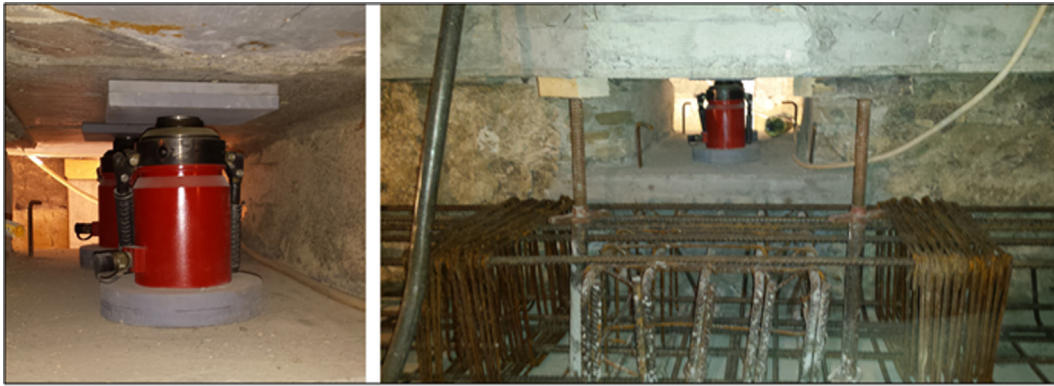
Fig. 9. Position of the hydraulic jacks and LVDTs.

made, necessary for the execution of the raft foundation (Fig. 9).

All hydraulic jacks were instrumented with linear variable differential transformer (LVDT), having a maximum recording error of 0.01 mm, being connected to the same acquisition system, in order to constantly record the displacements between the superstructure and the infrastructure along the entire process of base isolation (Fig. 12). Besides that, an auxiliary displacement and settlement monitoring method has been implemented, being composed of 10 steel reference marks (RM1-RM10), socketed in the top and bottom r.c. elements, and 4 steady reference points (RS1-RS4), installed in positions that are not affected by the excavating works or by other technological processes. For the steady reference points, 4 r.c. piles were drilled and casted, having diameters of 300 mm and depths of 7 m. The steel reference points were embedded in the top part of the piles. The auxiliary monitoring method consisted in cyclic optical surveys of high precision, aiming to identify potential local or general settlements of the infrastructure elements or changes in the horizontal position of the building, especially during the load transfer stage (Fig. 13). Before chain-cutting the existing foundations, hence decoupling the infrastructure from the superstructure, the position of the socketed steel marks and the value of the LVDTs were recorded, being considered as equilibrium reference values during the lifting and lowering stages, since these values corresponded to the original position of the structure.

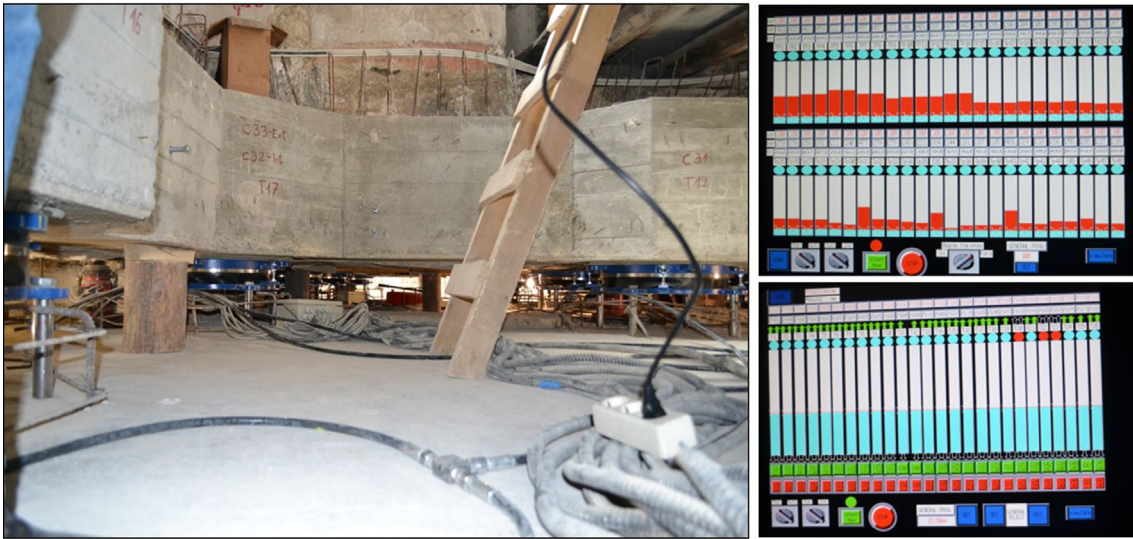
Fig. 15. Lifting process and the digital software for controlling the pressure in the hydraulic jacks.

Stage 6. In order to provide sufficient operating space between the top carrying frame and the raft foundation, necessary for completing the installation of the FPS supports, the superstructure was lifted. The operation has been done under displacement control, by imposing successive increments of 1 mm, up to a maximum value of 25 mm. Also, during the lifting process, the structure was brought to the initial horizontal equilibrium position, because minor local settlements were recorded by the LVDTs during the foundation cutting process, due to the load transfer from the existing footing to the temporary hydraulic jack supports (Fig. 15). Along the entire lifting process, the hydraulic jacks have been equipped with both mechanical and hydraulic blocking systems in order to avoid potential damages due to local pressure losses or even failures.

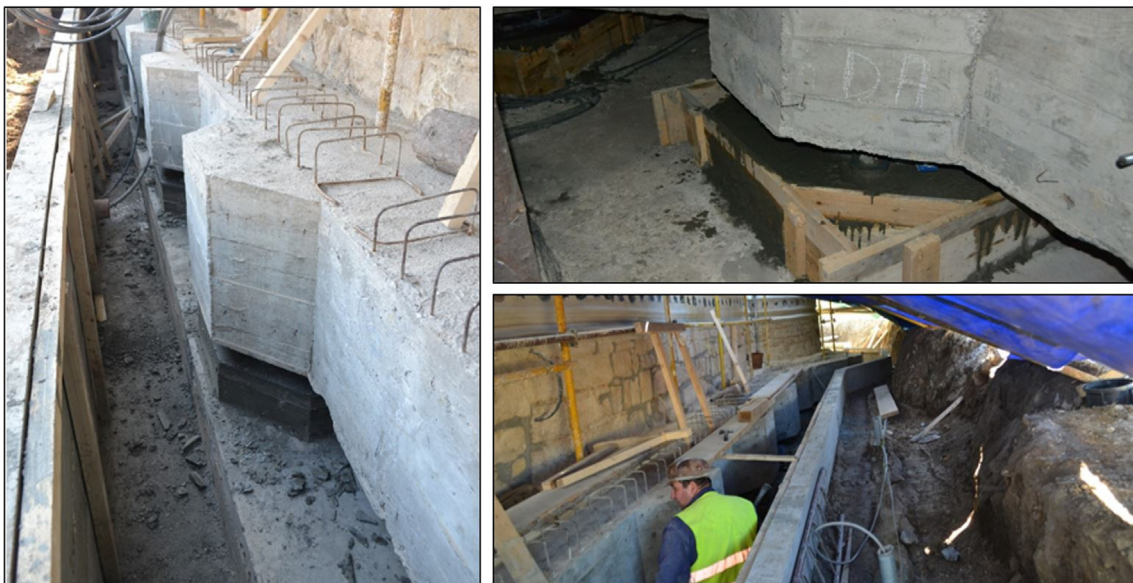
Fig. 16. Casting the base of the FPS isolators.

Stage 7. Once the structure has been lifted, the position of the FPS isolators was rechecked and, after minor calibrations, their base was executed. For the latter, a fluid micro concrete (class C30/37) has been used, having graded aggregates with maximum size of 8 mm and very low contraction and expansion coefficients (Fig. 16). After the concrete cured, the lowering process started. During this stage, the pressure in the hydraulic jacks was simultaneously decreased, being correlated with the displacements given by the LVDTs in order to ensure a constant and balanced descending process. After the load was entirely transmitted to the FPS isolators, the horizontal position of the superstructure was verified (based on LVDTs recordings and on topographic methods), aiming to determine if it corresponds to the one which was recorded in stage 4, considered as equilibrium reference value. The maximum relative deviations ranged between -0.25 and $+0.30$ mm.
